# TECHNICAL SERVICE BULLETIN Underbody Shield Rattle Or Flutter Noise While Moving - Built On Or Before 05-Jun-2019

**21-2322** 23 September 2021

<b>Ford</b> 2015-2019 Edge
<b>Lincoln</b> 2016-2018 MKX
2019 Nautilus

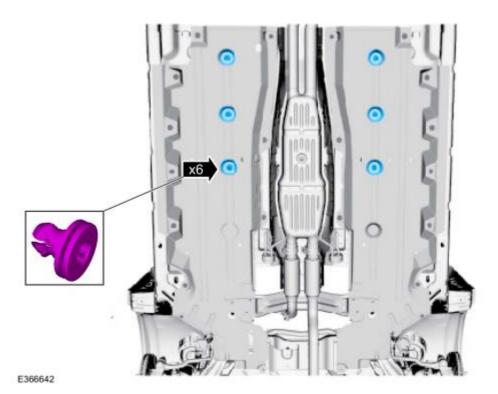
Figure 1

**Issue:** Some 2015-2019 Edge, 2016-2018 MKX, and 2019 Nautilus vehicles built on or before 05-Jun-2019 may exhibit a rattle or flutter noise from the underbody of the vehicle while moving. This may be due to the movement of loose underbody shield fasteners which are attached to the underbody shields. To correct the condition, follow the Service Procedure to remove the assembly aid fasteners.

- 1. Raise the vehicle on a hoist. Refer to Workshop Manual (WSM), Section 100-02.
- 2. Remove and discard the assembly aid fasteners. (Figure 1)
